HA-1104 CAMERON-CURRIER LIVERY STABLES Havre de Grace, Md.

INVENTORY FORM FOR STATE HISTORIC SITES SURVEY

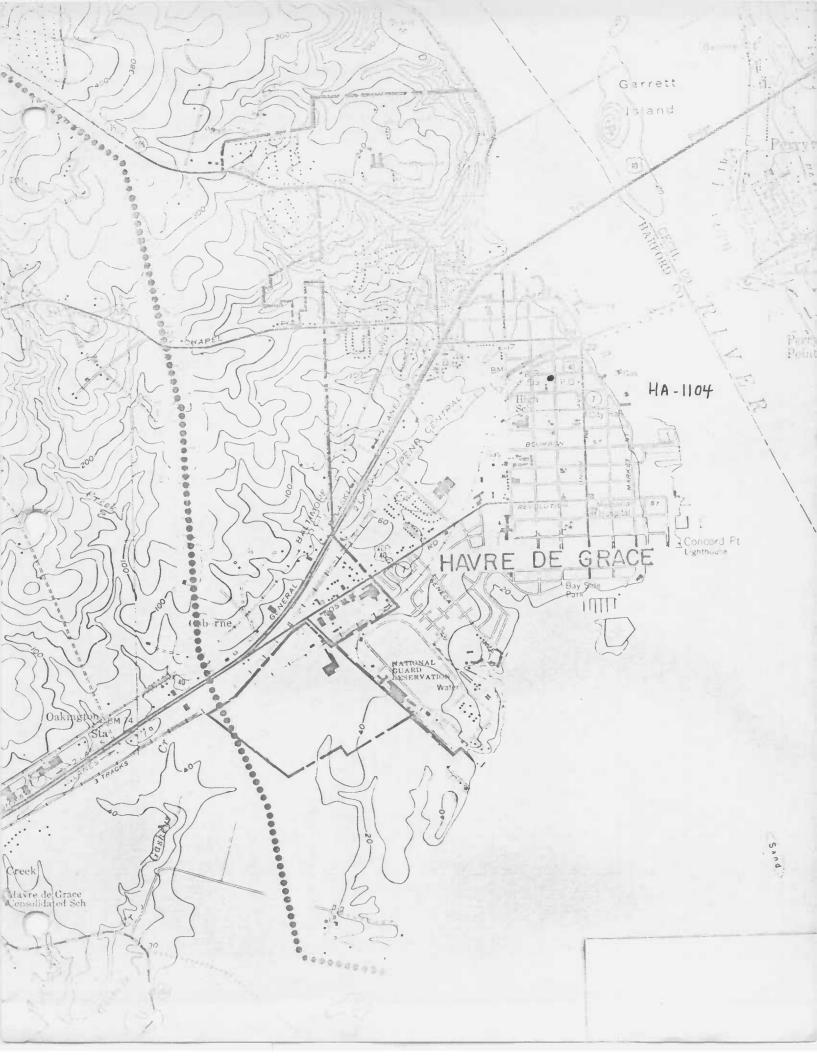
Cameron-Currier Livery Stables
HA-1104
N. Stokes and Franklin St, Havre de Grace
Marion Morton, July 1976
Southeast elevation
